# Electrical Safety Alert

## Voltmeter Probes Catch Fire While Testing 120V Outlet

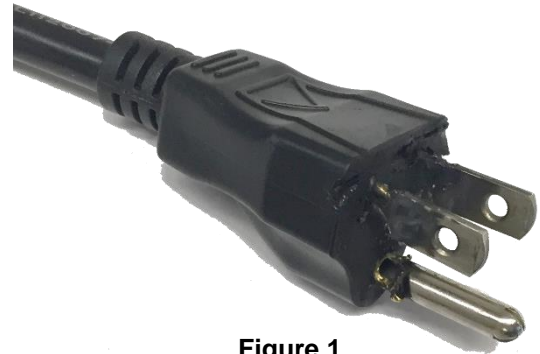
Figure 1

A researcher was attempting to plug into a standard 20A wiremold outlet. View of the outlet was partially blocked by a wall-mounted shelf above the wiremold. A niobium level sensor rod was stored on top of the wiremold. The rod was knocked off the wiremold and fell between the plug blades and ground pin as the researcher pushed the plug into the outlet. This created a short circuit as the connection was completed, causing arcing between the plug and outlet (Figure 1). A 1000A circuit breaker in an upstream panel tripped from the ground fault, deenergizing the faulted circuit.

- Do not store materials on wiremold strips, or directly above receptacle outlets.
- When testing damaged electrical equipment, use extreme caution. Ensure that conditions are known, and use PPE and electrical safe work practices appropriate for the conditions and equipment.
- Damaged electrical equipment must be Locked and Tagged (LOTO'd) at the source and verified de-energized.
- Multiple isolation points require Complex LOTO with a written procedure and verification.

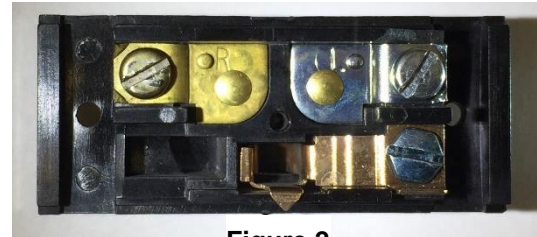
Figure 2

Analysis of the damaged outlet after removal from the wiremold showed very little damage to the internal components of the outlet. Furthermore, the likelihood of some contact between the hot and neutral blades, or hot and ground blades was nearly impossible, as disassembly of the outlet showed complete separation inside the outlet (Figure 2).

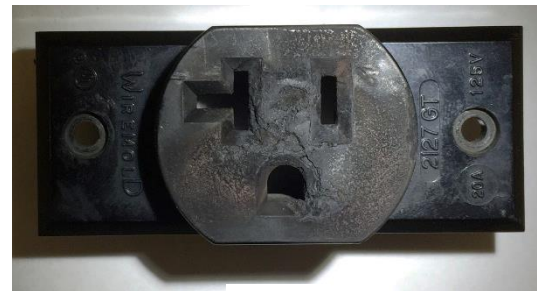
Figure 3

Further examination showed that the front of the outlet was not only damaged (melted), but that it had a thin film of soot and discolored material (Figure 3). Application of a multimeter showed continuity across the face of the outlet (Figure 4), and it was found that metal vapor from the plug, as well as the niobium rod had been deposited to the face of the outlet. Testing across multiple points on the face of the outlet showed readings ranging from 9 to 100 ohms. It is surmised that when the electrician inserted the voltmeter leads into the outlet, it created a short circuit across the face of the outlet.

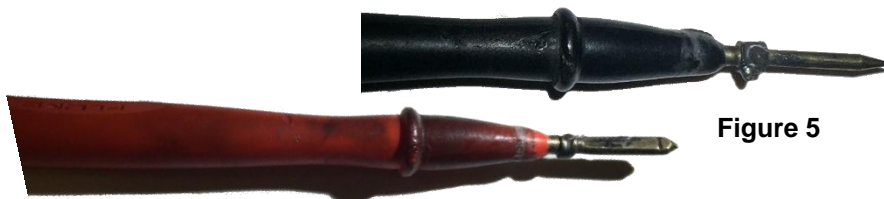
Figure 5

An electrician was dispatched the next day to troubleshoot power issues for the researcher and scope out repairs. The researcher requested that the damaged outlet be tested. The electrician inserted the voltmeter probes into the damaged outlet to get a voltage reading. When the Fluke T5-1000 probes were inserted into the outlet, sparking occurred, and the plastic of the Fluke CAT III / IV probe tips caught fire and had to be extinguished (Figure 5).
